Integrated Approach for the Safety Evaluation of Masonry Bridges

Valerio Sabbatini, Silvia Santini, Claudio Sebastiani and
Eugenio Ricci

CODE 308**INTEGRATED APPROACH FOR THE SAFETY EVALUATION OF MASONRY BRIDGES**

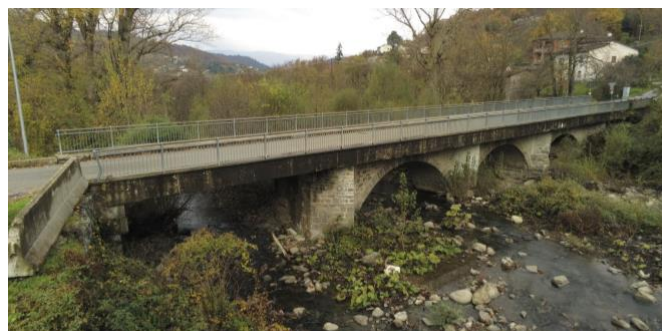
Figure 1 Overview of the Limentra bridge

The Limentra bridge is a multi-span masonry viaduct located in the province of Pistoia, Tuscany (Italy) on the Province Route SP 51 (Figure 1).

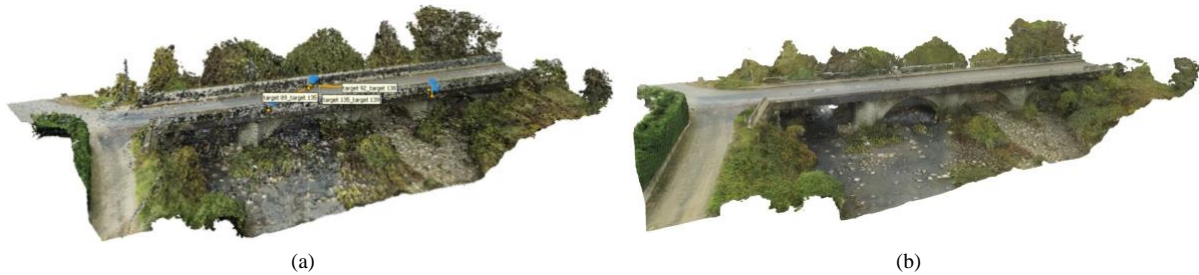
Figure 5 Geometrical survey of the Limentra bridge: (a) point cloud, (b) texturized tiled model.

about two hours with the use of a small Unmanned Aerial Vehicle (UAV) of 0.32 kg of weight, equipped with 21 MP camera. Twenty markers were positioned on the bridge to scale the model and facilitate the merging operations. The point cloud of the site was assembled with the software Agisoft Metashape [5] using 445 photos (Figure 5a). The data was further processed to define the three-dimensional tiled model of the bridge including the dimensional texturized surfaces that represent a fundamental reference for the identification and localization of the structural defects (Figure 5b).

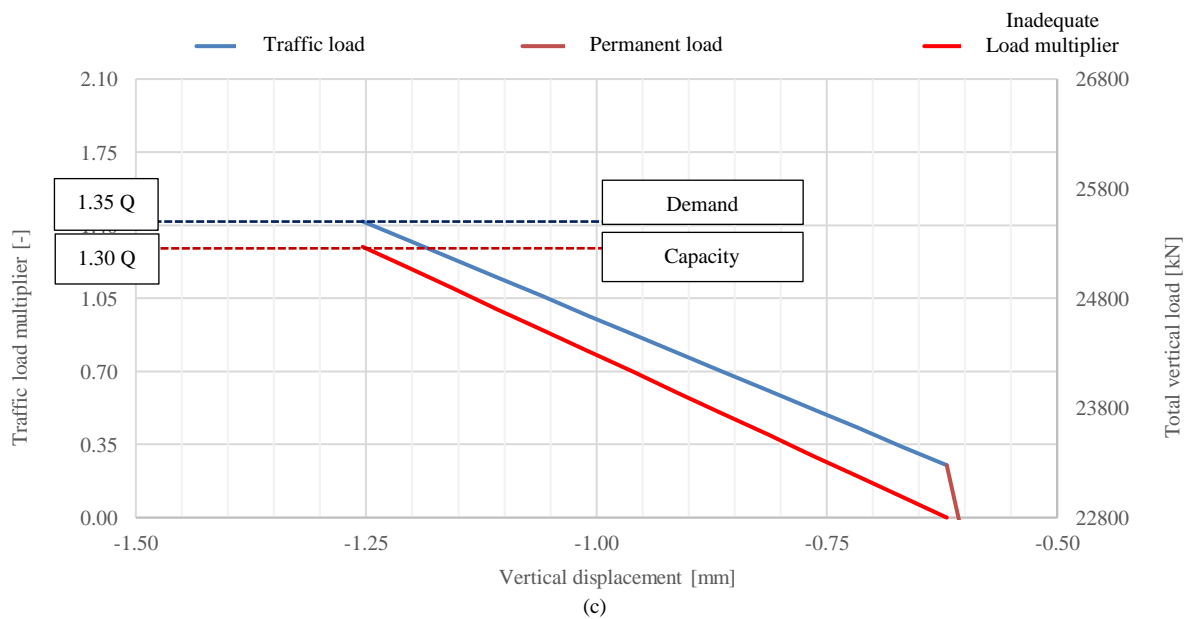
Figure 11 Results of the nonlinear analysis to maximize the load on bay P2-P3: (a) vertical displacement at the final step of the analysis – load multiplier 1.3, (b) material status of the elements at the final step of the analysis - load multiplier 1.3, (c) capacity curve function of the load multiplier and total applied load, (d) compression principal stress at the final step of the analysis – load multiplier 1.3, (e) tension principal stress at the final step of the analysis – load multiplier 1.3, (e).

Two different control nodes were selected based on the largest vertical displacements (Figure 10a, Figure 11a). The capacity curves were represented in terms of total applied load and load multiplier of the characteristic vehicular load respect the vertical displacement of the control node, the plotted curves track the respond of the structure during vehicular traffic. Being both load and displacement in the vertical direction, the governing failure mechanism does not provide significant nonlinearity (Figure 10c, Figure 11c). In Figure 10b and Figure 11b is reported the material status which identifies the element failure (in red) and stress change during cracking (in blue). The compression stress agrees with the material compressive strength (Figure 10d and Figure 11d), the tensile stress is larger than the tensile strength (uniaxial) since the state of triaxial stress provides confinement thus additional capacity (Figure 10e and Figure 11e). Load configuration in Figure 10 reaches maximum load multiplier 2, thus pier 3 is adequate to carry the prescribed traffic load. Load configuration in Figure 11 reaches maximum load multiplier 1.3 (below the limit value 1.35), thus bay P3-P2 is not adequate.
